**KOLDAM HYDRO ELECTRIC  
POWER PROJECT**

**(4 X 200 MW)**

**TARIFF OF KOLDAM HEP FOR THE  
PERIOD FROM 01.04.2024 TO  
31.03.2029**

**Tariff determination petition (2024-29) of Koldam Hydro Electric Project (4 X 200 MW)**

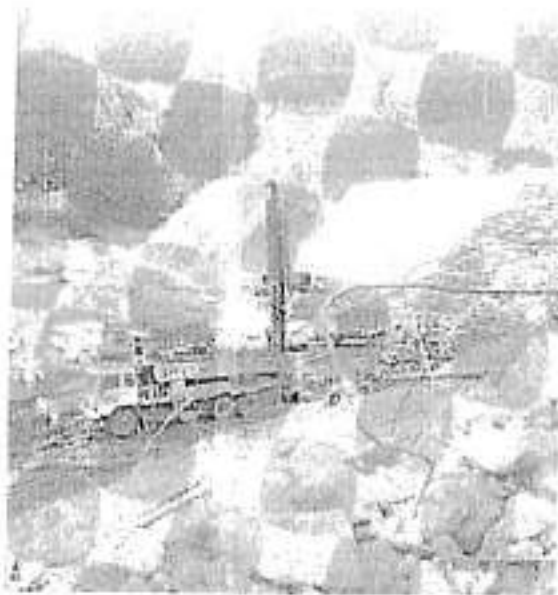
The Plunge Pool is mainly occupied by carbonaceous phyllite which is a very weak rock. Some remnants of the basic dyke could be observed at higher level on left bank in the downstream end of the plunge pool. Rock ledges protruding into the plunge pool were observed. PoE is of the opinion that this protrusion would be eroded in due course of time naturally; it does not require to be blasted with special efforts.

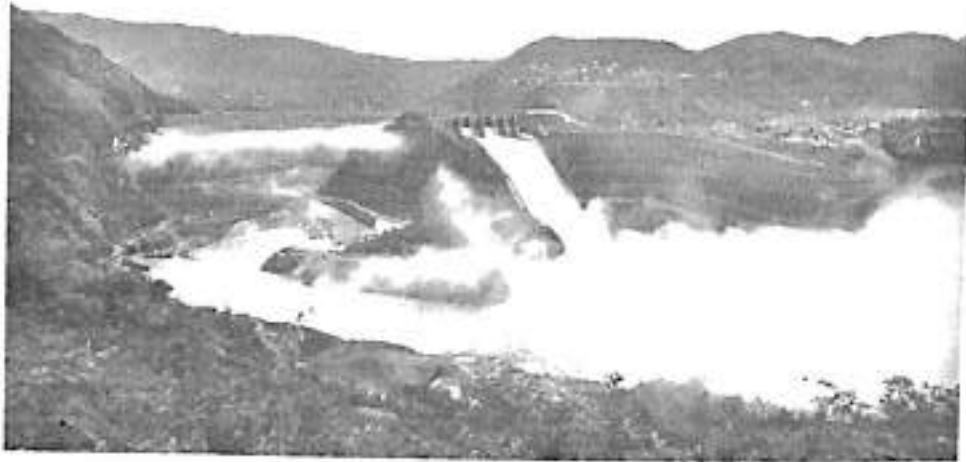
Photograph showing the passage of floods over the ski jump

The flow pattern after the impingement of ski jump jet on the downstream has been complex, and the near 90° turn of river to the left creates swirling action on either side. This has eroded the right bank and hill slope damages, taking away some slope wash material.

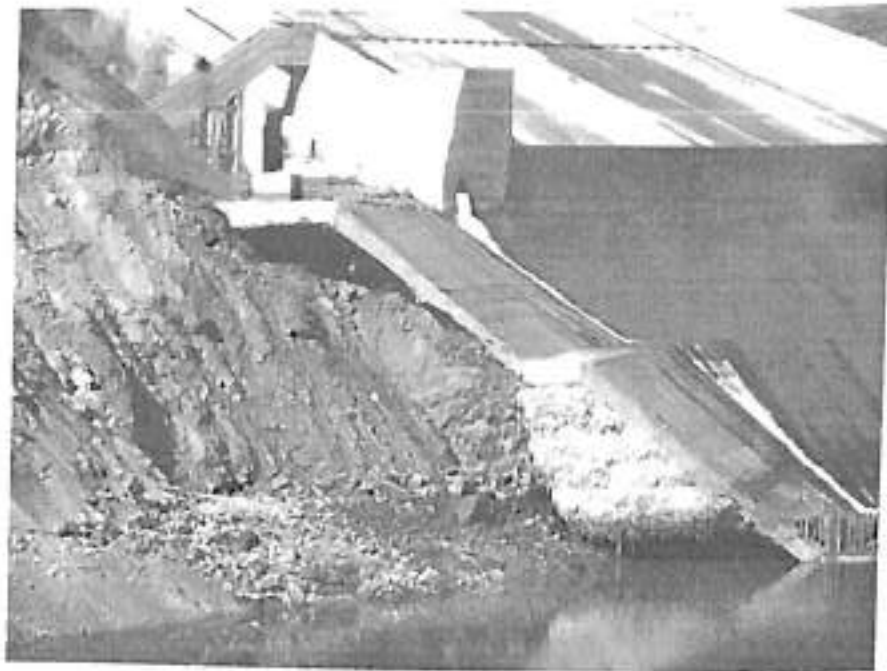
Photograph showing cavities below cladding on the right bank

This process does not require any equipment to be brought up to the cavity location and an ordinary manual path 1.5-2.0m width only need to be made for access. The work could thus start within a week of availability of contractor at site. Enough boulders are available in the plunge pool bed and thus no material is to be transported to site.

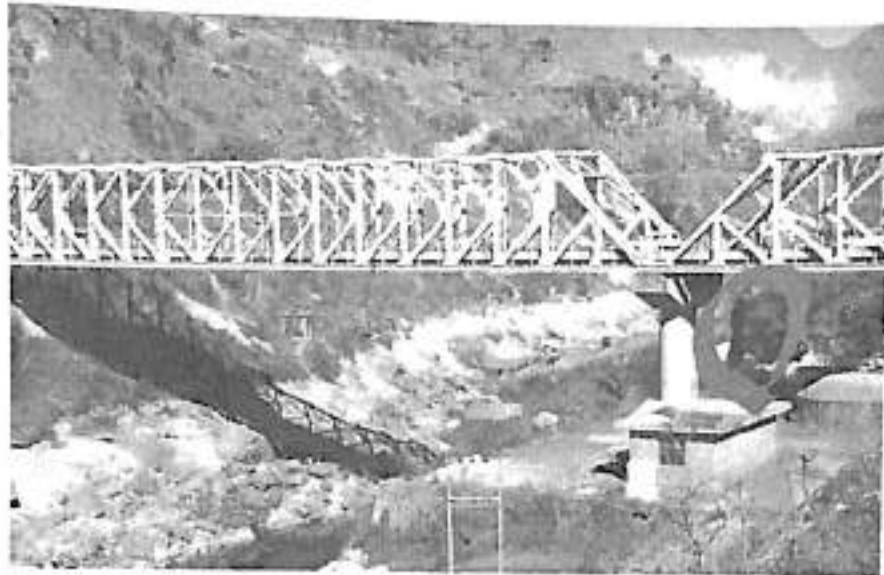
## Maitri Bridge

One of the significant control section of the river in the downstream is observed to be the Maitri bridge location. The river flows through a narrower section. Because of some civil works undertaken on the right bank, besides the intermediate pier foundation interference of the flow is possible. This also could constrain the flow behaviour affecting the hydraulics downstream of ski jump energy dissipator.

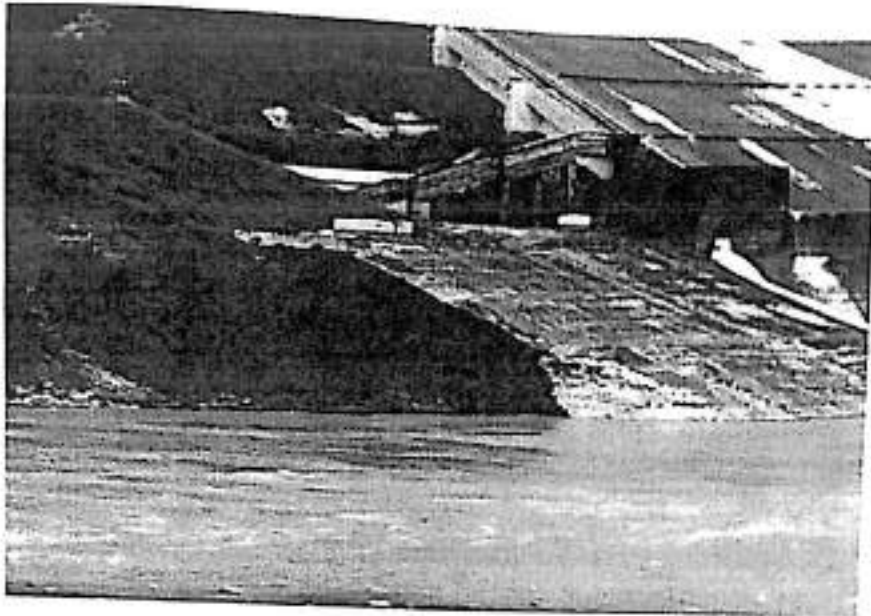
### Some views of damages (RF)

During the current monsoon in 2017, the spillway operation had resulted in certain damages again, on right side of plunge pool. Taking stock of the situation after inspection at site, PoE observe that the backfilled concrete placed in cavity behind the right cladding wall (including the backfilling done in 2016) has been scooped out and washed away. Some related works advised by EDF and completed by NTPC, in respect of micro-piling had also failed to serve its intended purpose. PoE was informed that all the works related to backfilling of the cavity could not be completed; some gap at the bottom has remained open to water access.

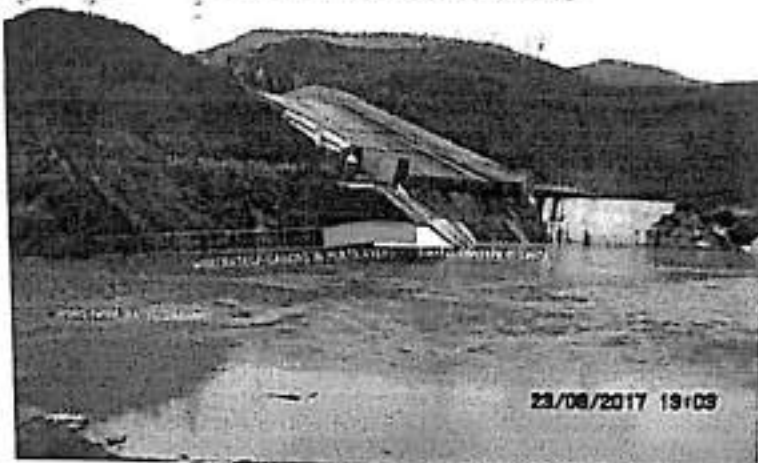
## PROPOSED PROTECTION WORKS

c. PoE advise that placement of concrete bags dumped behind the cladding is not resorted to as suggested by project during discussions on 12.09.2017). After filling the cavity with concrete the exposed face at the end of cladding shall be covered by placement of boulders upto El. 512 m i.e., max possible water level, encountered corresponding to say 1500 cumec discharge and

keeping in view backwater effects due to Bhakra reservoir. The boulders (unrounded / blasted that can interlock) may be placed in a manner to provide a gradual transition from end of concrete cladding (including backfilled concrete) to the exposed rock slope downstream so that the space for backflow on right side gradually decreased. Alternatively the use of tetrapods or tripods of individual weights of one tonne minimum weight, laid in multiple layers, (duly interlocked) can be explored and adopted.

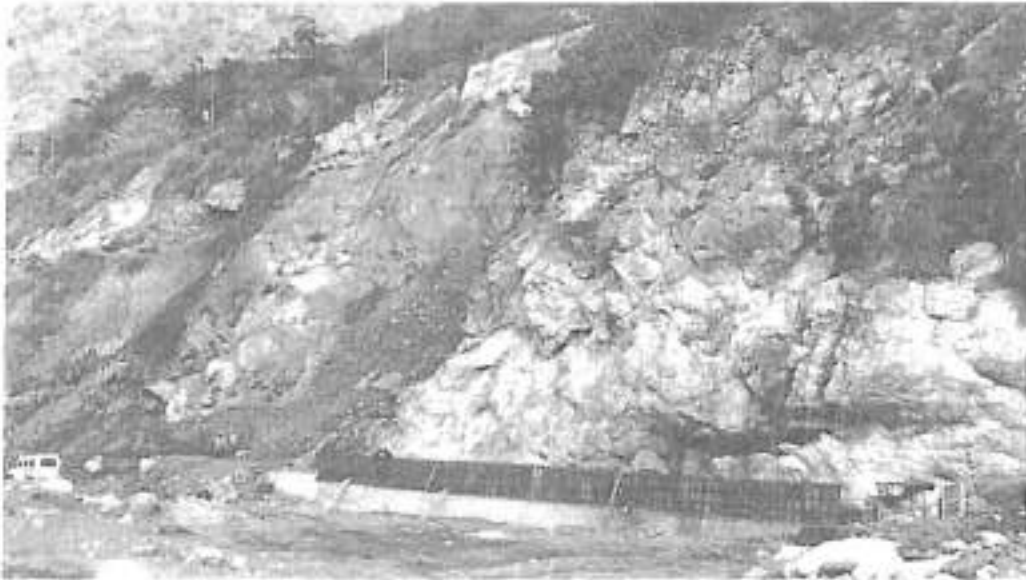
## Agenda 2 – Right Bank River Protection Works Downstream of TRC

POE was presented the status and details of protection works proposed for the right bank river slope in front of the Plunge Pool in the 16<sup>th</sup> Meeting in Sep 2017. The works included concrete cladding of the portion of river bank slope in rock as well as rockfill shell protection covered by concrete or rock riprap in portion, where rock is not available. POE had endorsed the above, earlier.

Some work of the concrete cladding has recently been started. The Project now inform that it is not possible to arrange for boulders of sizes 600mm to 900mm. In view of this, it is now proposed to place Gabions (Boulder wire crates), in place of rip rap. POE observe during site visit that dredging in the river bed downstream of TRC towards plunge pool right bank is being carried out. A considerable amount of river borne material has deposited in the middle portion of the river channel, thus creating a raised island, which obstructs the flow during operation of the power house.

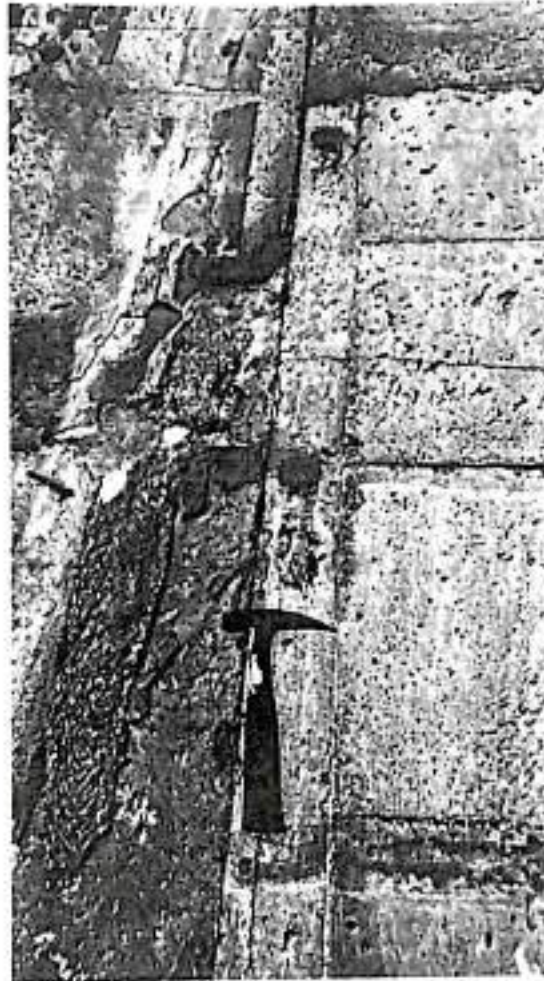
**Photo 2 : Typical Longitudinal Dilation joint which is smooth and straight and doesn't show signs of cracking**

In the longitudinal direction i.e. in the direction of Spillway flow, there are four dilation joints as per the construction drawings. It was observed that in line with the earlier PoE recommendations, these joints were filled with PU material. It was given to understand by construction engineers that after filling the joints with PU material, surface was smoothed by plaster. Continuous lines from Flip Bucket towards Aerators is observed along all the four longitudinal dilation joints. These joints are generally tight but contact between two blocks display rough edges all along the dilation joints. It is observed that at some places, for grouting the joint openings it was chipped off in V shape and backfilled with plaster. Cracks are observed on this plastered surface which are in wavy/ haphazard in nature.

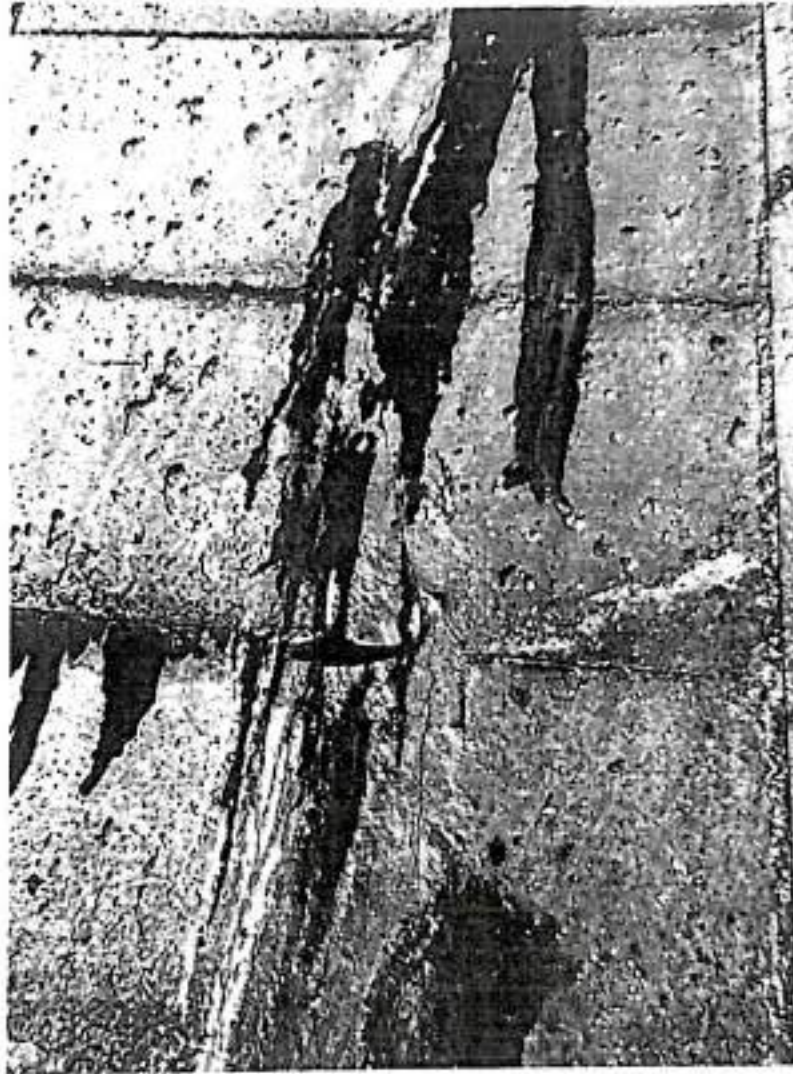
**Photo 3 : PU grout filled in the cracks, covered with plaster**

In addition to above, at some places small blocks of concrete (about 150cm in length & about 20cm in width) are observed to be detached along edges of dilation joints. This may be result of minor cracking in concrete along pre-existing dilation joints. The same needs to be backfilled with high strength concrete.

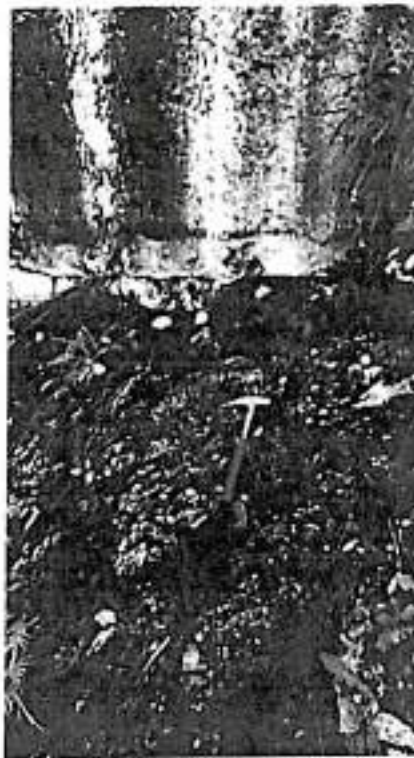
**Photo 6 : Outcrop of basic dyke on the left guide wall.**

The ground adjoining the left guide wall was also inspected upto first aerator and attempt was made to see whether the joint opening in the guide walls and floor are extending into the rock also. It was observed that no extension of joint opening (joint between flip bucket & chute and first block & second block) was visible into the ground beyond guide wall. The crack between flip bucket & plunge pool was observed to be extending into the ground beyond guide wall also . Further, gaps were observed between left guide wall concrete and basic rock exposure in the ground at some locations where water was flowing out which requires to be suitable treated.

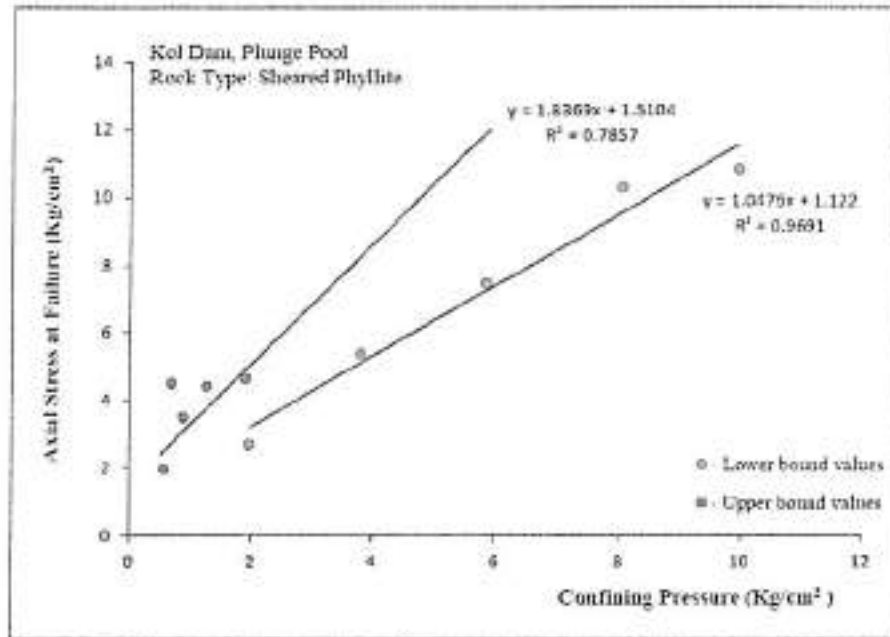
As per CSMRS report, for triaxial test, entire test data is scattered in two different zones (Fig. 1). For low confining pressures ( $0.6 \text{ kg/cm}^2$  to  $1.9 \text{ kg/cm}^2$ ) upper bound value of  $c=0.6 \text{ kg/cm}^2$  and  $\phi = 17^\circ$  and for high confining pressures ( $0.2 \text{ kg/cm}^2$  to  $10 \text{ kg/cm}^2$ ) lower bound value of  $c=0.2 \text{ kg/cm}^2$  and  $\phi = 6^\circ$  are suggested by CSMRS.

Fig. 1: Triaxial Test Results for Sheared Phyllite (CSMRS report Figure 20)

It can be seen from Fig.1 that there is a large scatter in the triaxial test results, whereas, direct shear test on remolded samples done treating the material as soil shows consistent results. Therefore, considering uncertainty in results of triaxial test, it is recommended that shear strength parameters derived from Direct Shear tests on remolded samples may be used for the stability analysis.

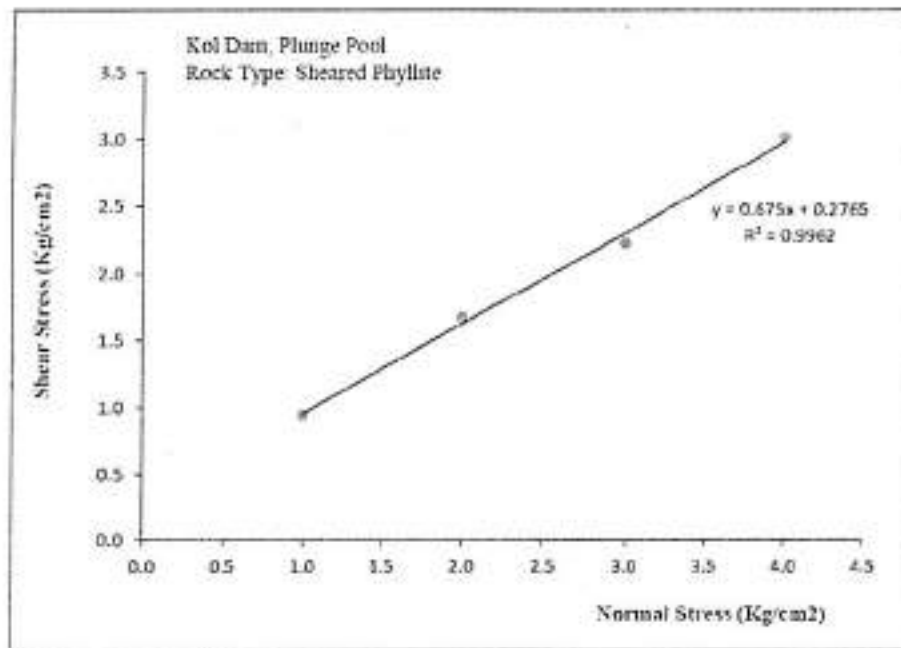
As mentioned in the CSMRS report, Direct Shear Tests were performed on remolded samples of Sheared Phyllite at normal pressures  $1 \text{ kg/cm}^2$  to  $4 \text{ kg/cm}^2$ . The normal stress vs. shear stress curve shows excellent fit with  $R^2 = 0.90$  (Fig. 2).

Fig. 2: Direct Shear Test Results for Sheared Phyllite (CSMRS report Figure 21)

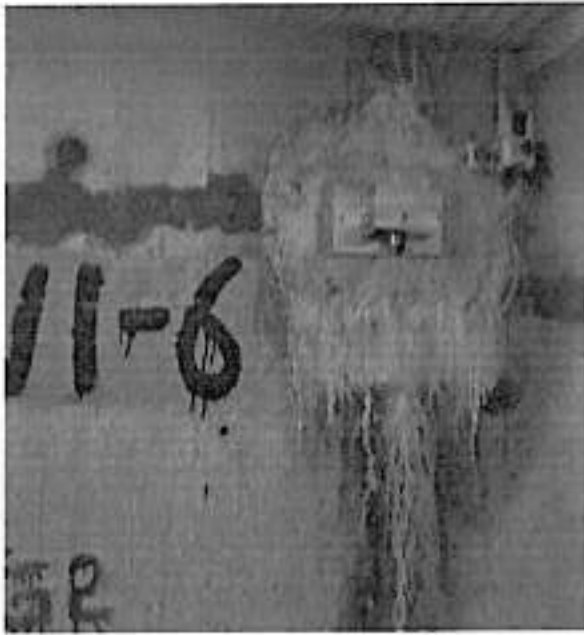
Jointmeter (Vinchen apparatus)

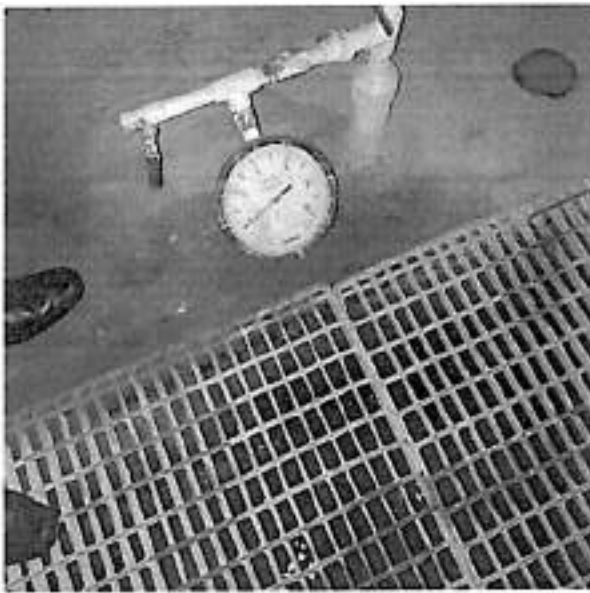
Pore Pressure Measurement

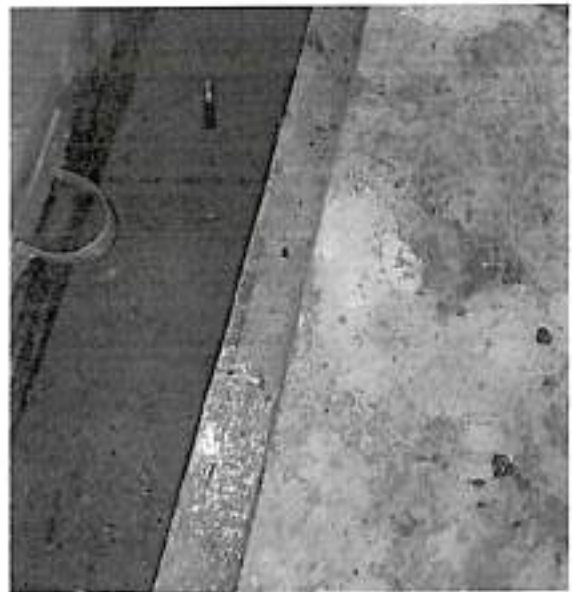
Automatic Water Level Measurement in Drain

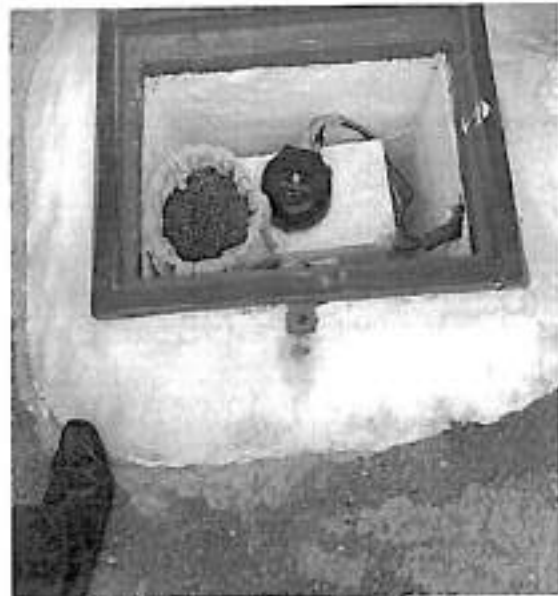
Strong Motion Accelerograph near the Right Abutment on the top of Dam

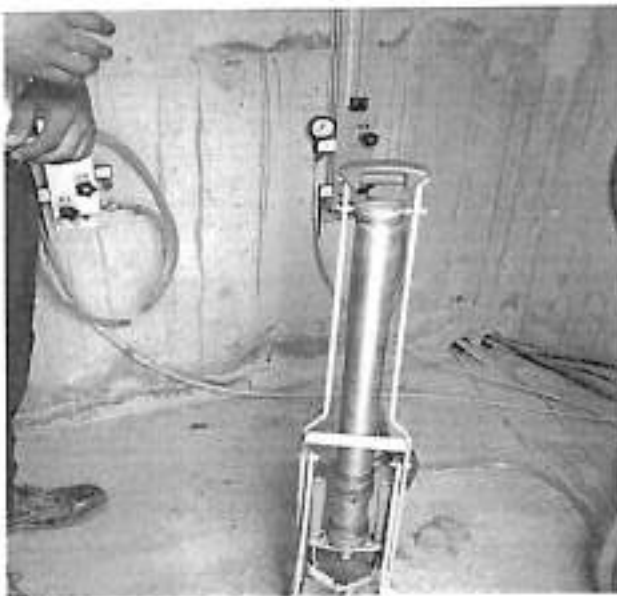
Cell Settlement System in the Dam Body on the Downstream Side

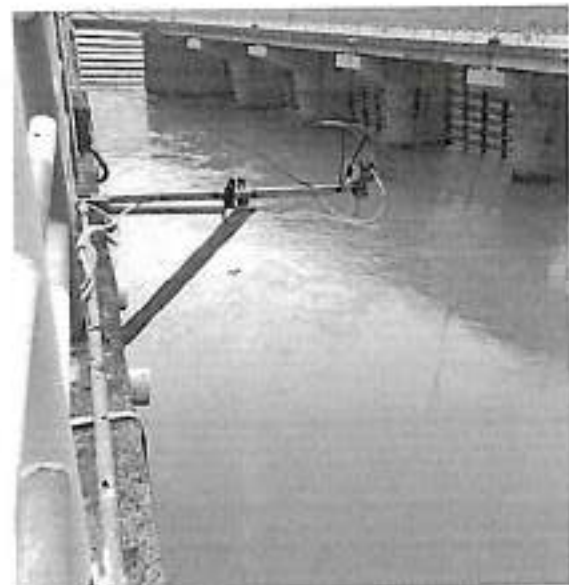
Automatic Water Level Recorder

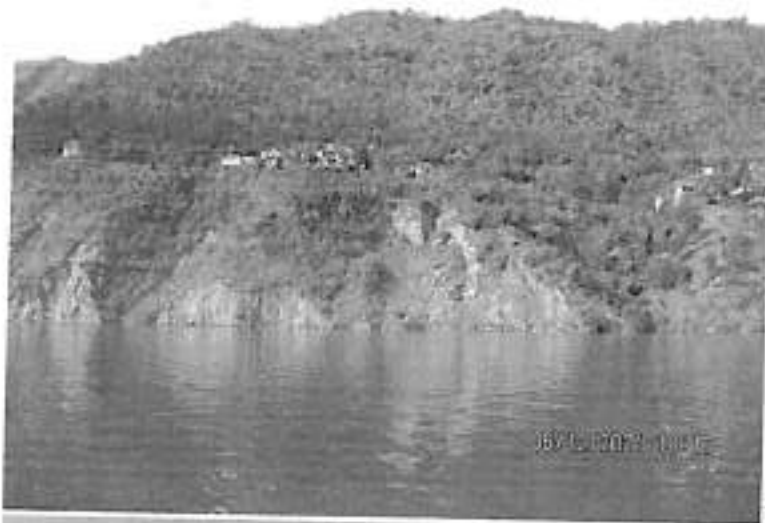
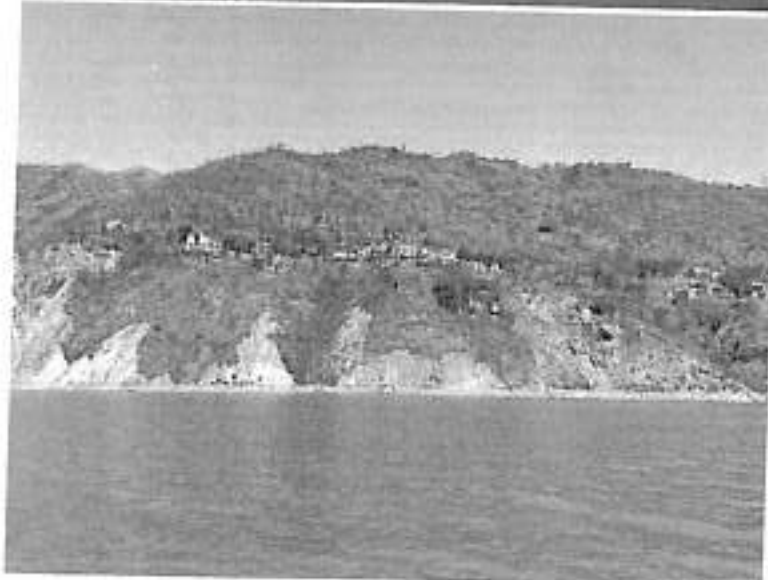
**B) Chamvon Slide**

**JUNE 2021**

**DEC 2021**

**MAY 2022**

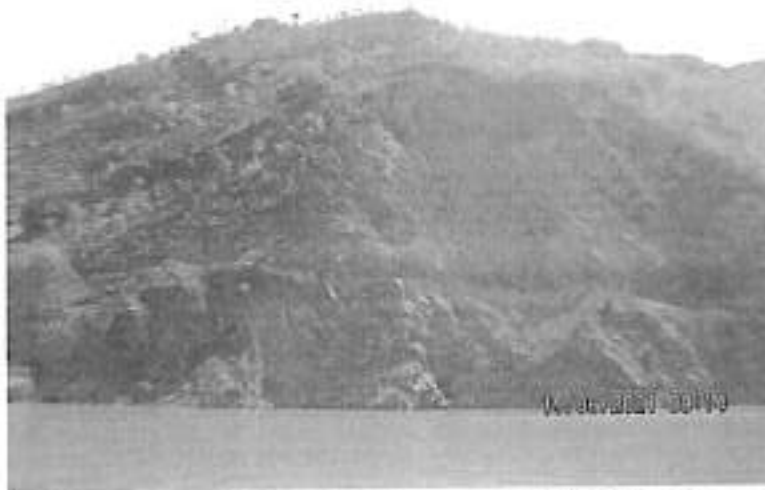
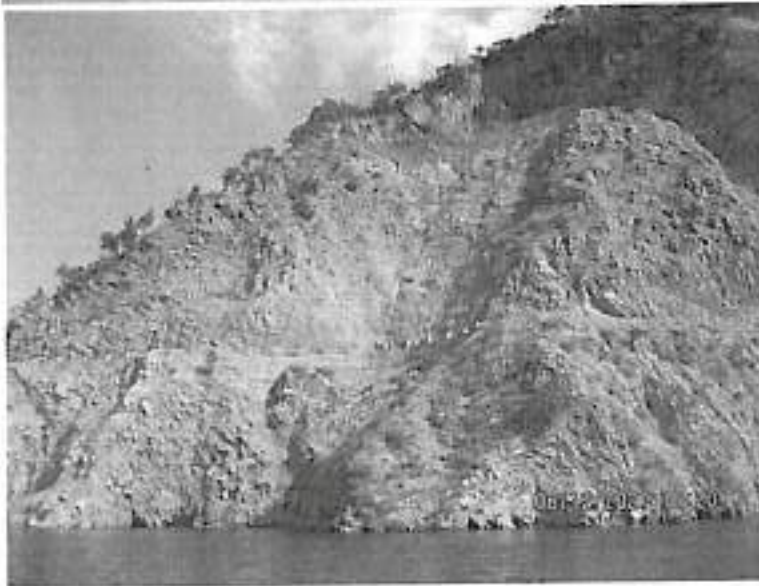
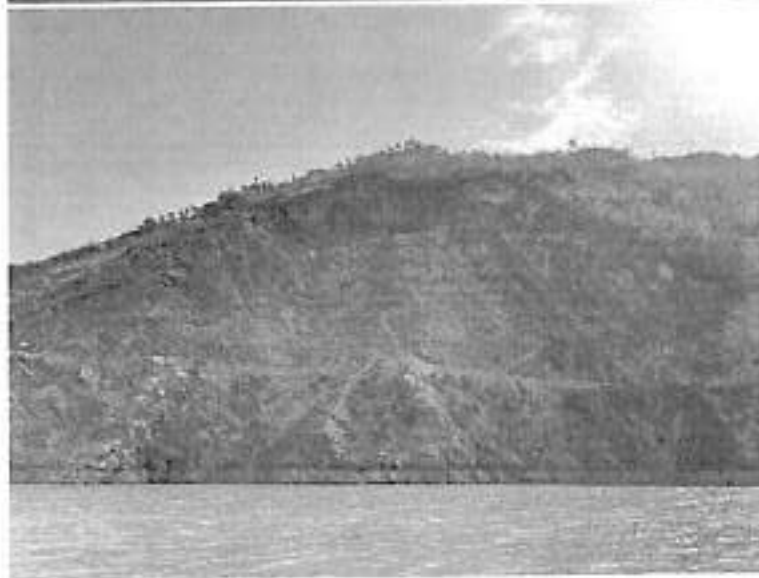
C) Kyan-Ahhan road slide

JUNE 2021

DEC 2021

MAY 2022

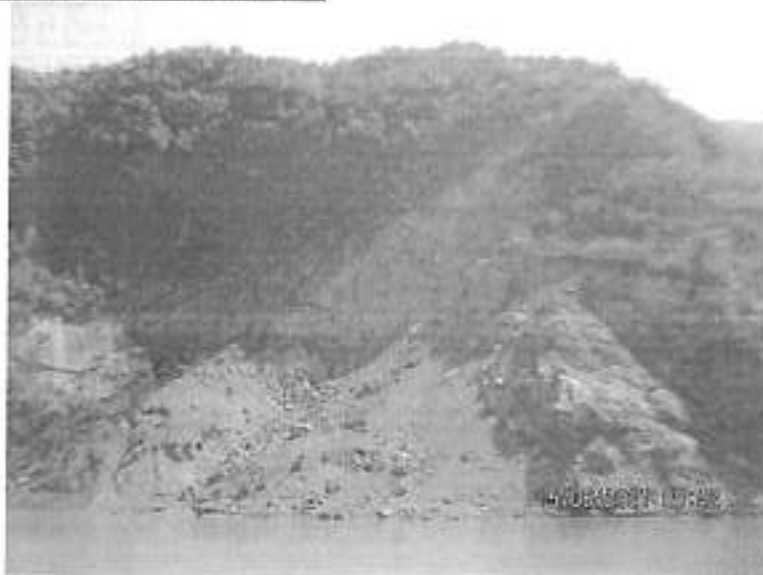
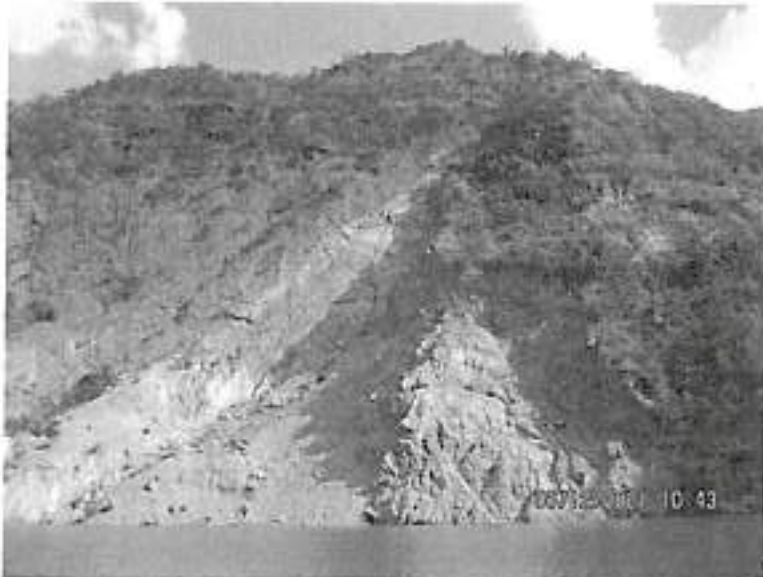
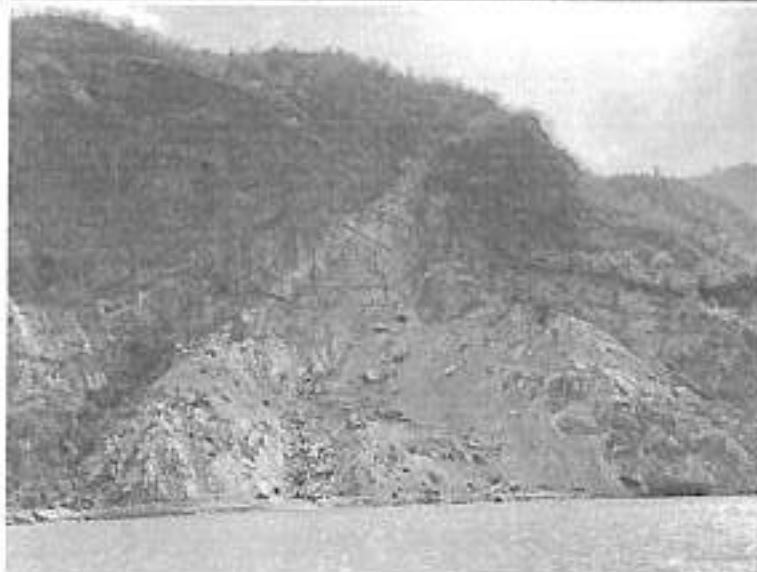
**F) Downstream of Village Neri, Right bank**

**JUNE 2021**

**DEC 2021**

**MAY 2022**

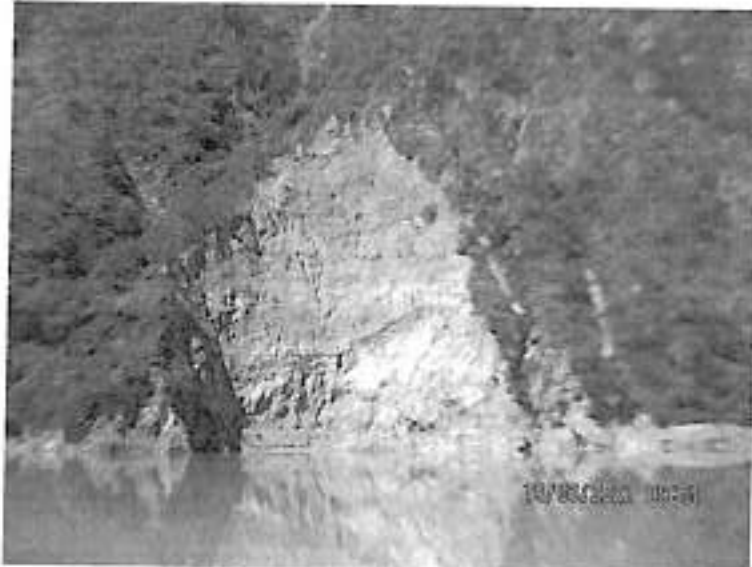
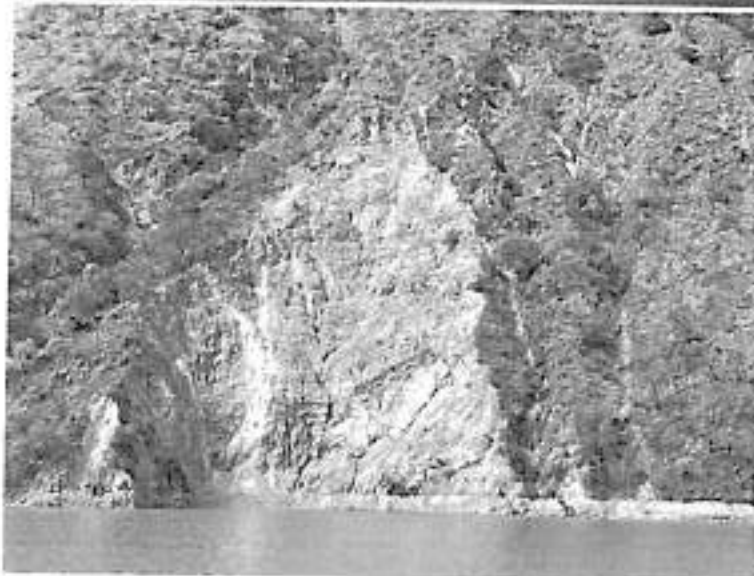
**G) Slide between village Neri and village Dogri left bank :**  
**(I)**

**JUNE 2021**

**DEC 2021**

**MAY 2022**

Two Slides between village Neri and village Dogri on (i) left bank and (ii) right bank of Reservoir. No habitation or agriculture field is located near to the slide and during pre monsoon inspection on 20.05.2022, the slide observed to be stable. (Photograph enclosed)

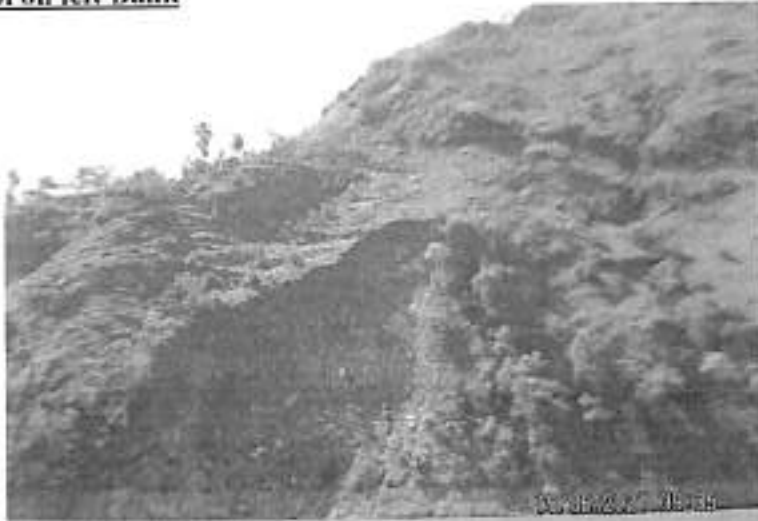
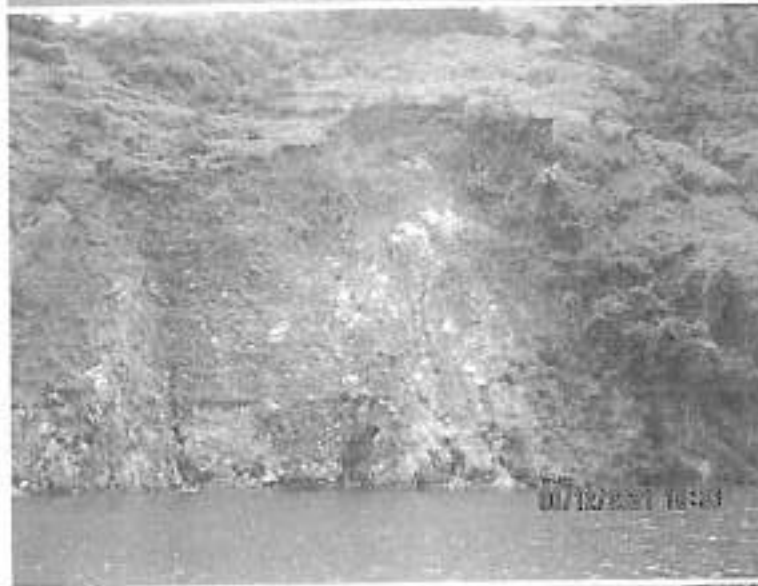
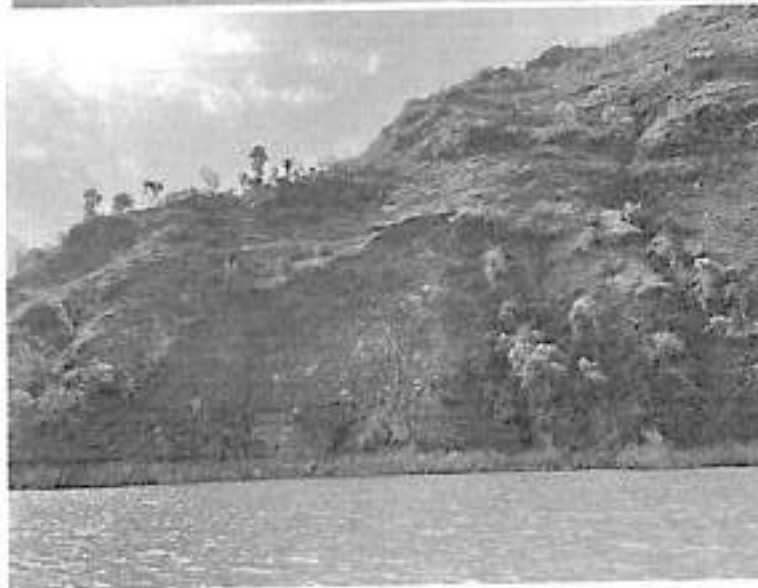
**H) Slide at Village Boi on left Bank**

**JUNE 2021**

**DEC 2021**

**MAY 2022**

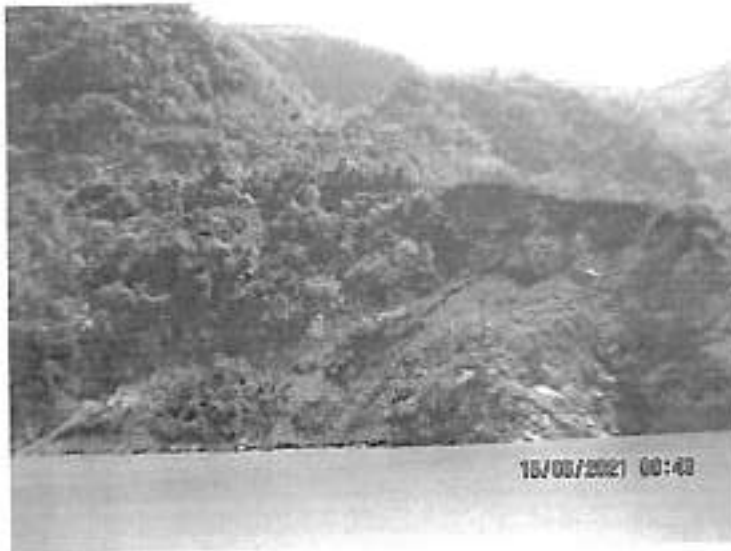
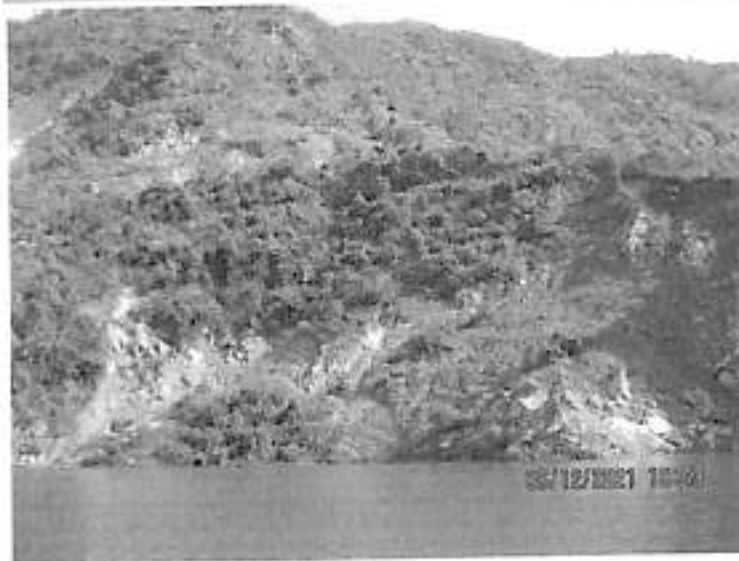
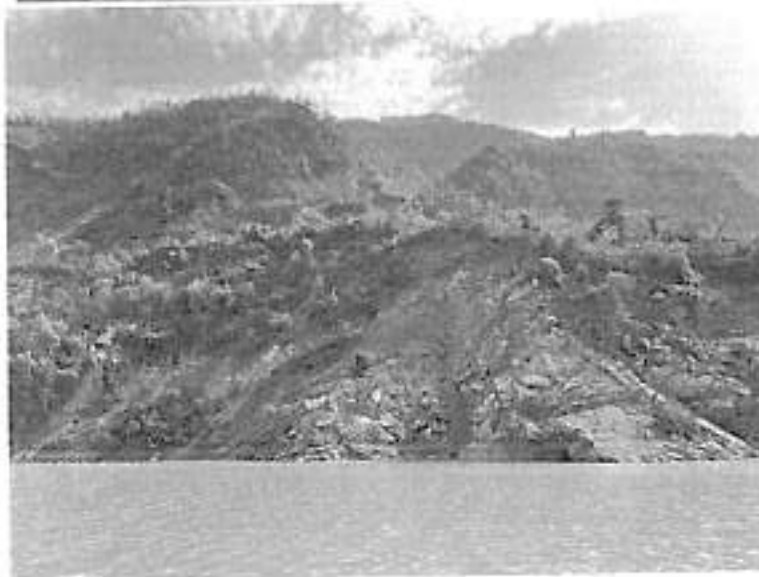
**(I) Right Bank**

**I) New Slides noticed near village Neri**

**JUNE 2021**

**DEC 2021**

**MAY 2022**

Two new slides were observed during post monsoon inspection in May 2017, during recent pre monsoon inspection on 20.05.2022, one of the slides found to be active and other one is stable and in similar condition, No residential house or agricultural land is located near the slide. (Photograph enclosed).

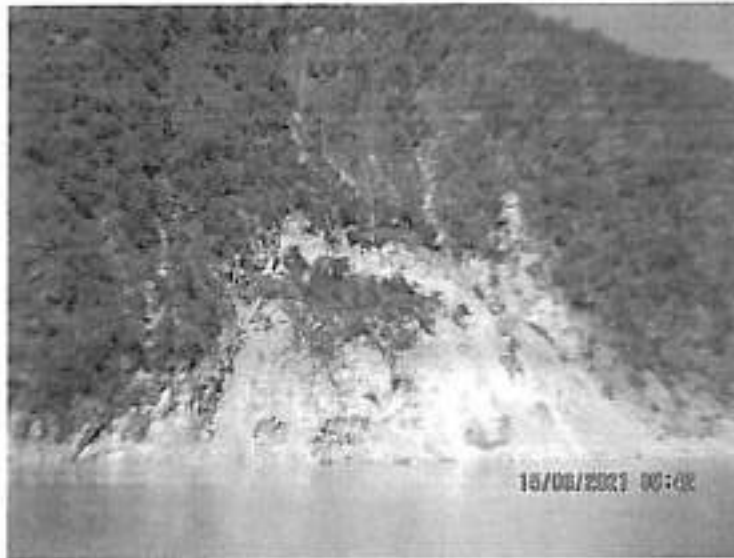
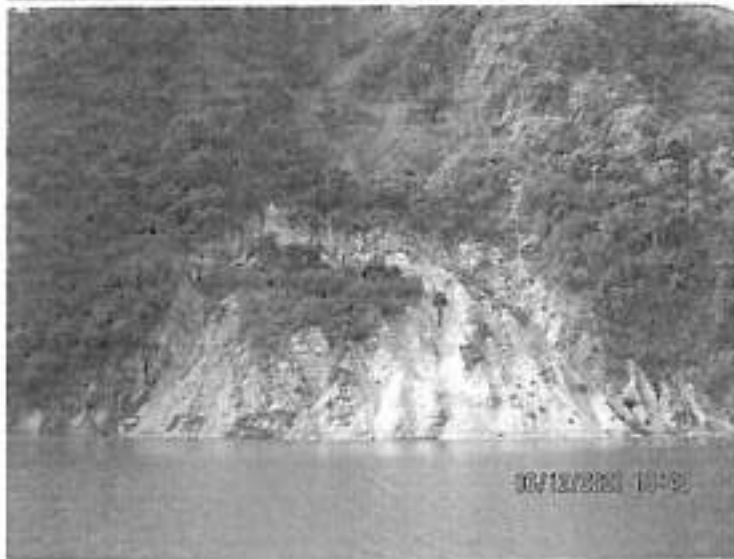
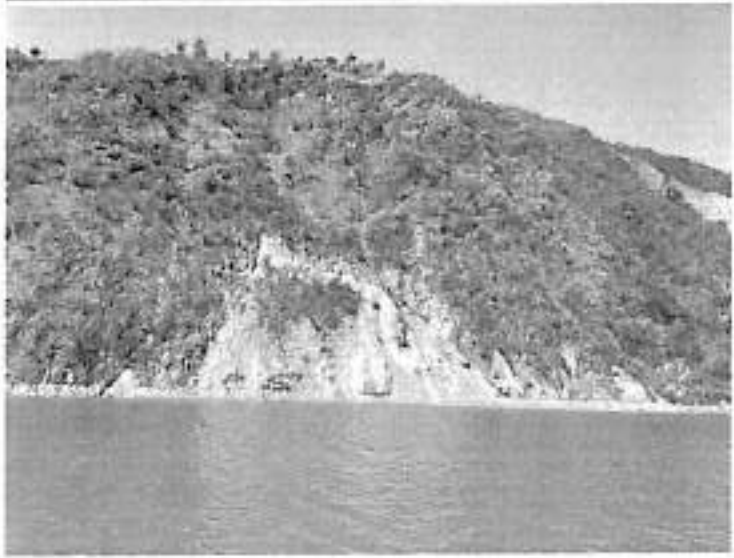
**II) Left Bank:**

**JUNE 2021**

**DEC 2021**

**MAY 2022**
